Reinvestigation of VT-ENF accident 08 June 2020

The Director-General,
AAIB India,
New Delhi.

The Cessna FA152 met with an accident soon after takeoff. Whereas the probable cause of the accident given in the final report is nonadherence of SOP by the crew leading to over banking while landing the investigators have not considered mechanical failure of the Flap mechanism.

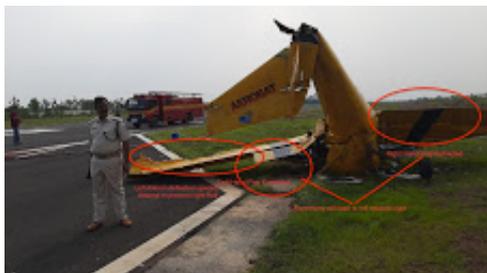
VT-ENF Flight Control.jpeg
145K

Media reports of the accident site and the aircraft show the flight controls of the aircraft deflected towards opposite sides. The three elements in question here are:

1. Flap position
2. Flap lever position (cockpit)
3. Aileron position

1. The actual flap position of LEFT FLAP shows fully extended whereas the RIGHT FLAP is fully retracted. This asymmetry will cause an inadvertent roll towards the right and the aircraft will bank right. Refer attached photo
2. The Flap lever position in the cockpit is slightly beyond the full retracted position. Refer photo.
3. The Left AILERON is deflected full UP indicating that the crew was attempting to correct the anomaly caused by asymmetry. The aileron deflection will cause the aircraft to roll left.

Therefore, prima facie this accident may not have been caused due to the crew over banking the aircraft leading to a stall but it could be a mechanical failure. The reasons and circumstances under which the FLAPS could develop an asymmetry needs to be investigated and the root cause determined in order to prevent further accidents.

This new evidence and previous such incidents do necessitate the re-investigation of the accident of VT-ENF.
